Using LPW's lab to rapidly complete a Root Cause Analysis of Powder Contamination.

LPW was approached by a customer operating an SLM Solutions machine to manufacture a component for an Industrial Gas Turbine application. Cracking was observed in the built component.

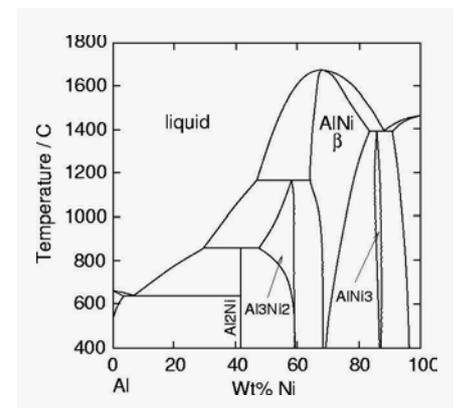
They found that Nickel has a very limited solubility in Aluminium which means that the brittle AlNi phases appeared in the microstructure, resulting in crack propagation sites.

Further analysis of the parts which failed revealed that the Nickel was fairly homogeneously spread throughout the Aluminium matrix of the component. An average of 5.2 wt% could be observed.

In specific areas wt% in excess of 40% could be identified, which indicates that we would have a presence of the very brittle intermetallic phases.
