Porosity in deposited material

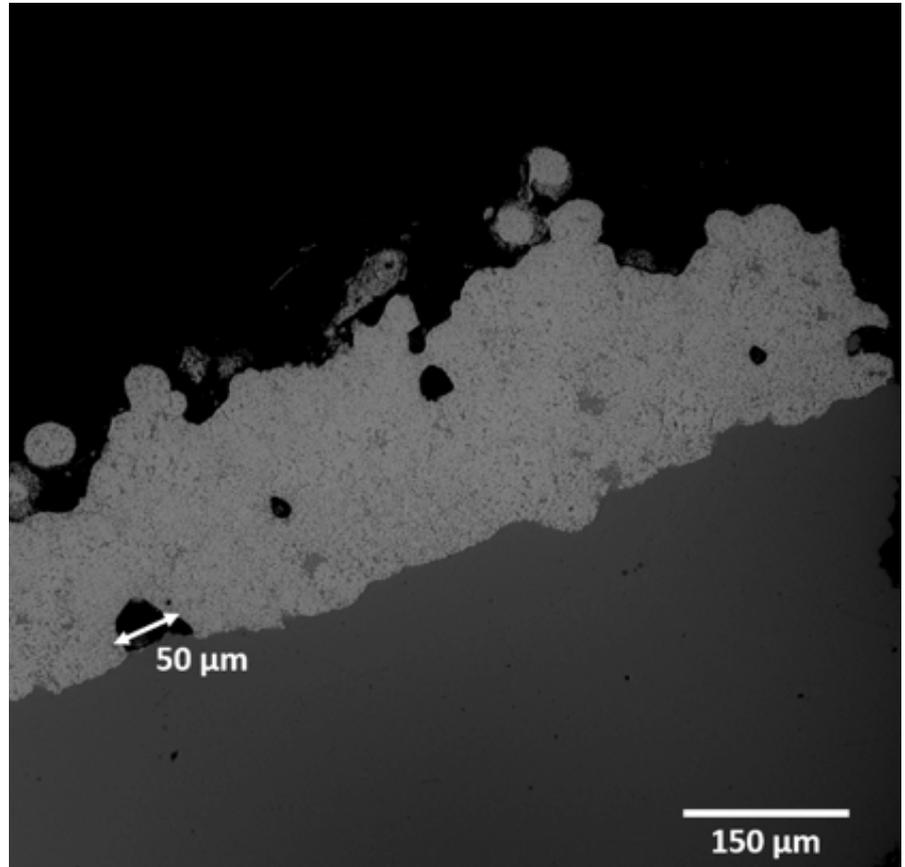
Microstructural analysis of samples of the deposited material were conducted to gain a better understanding of any potential processing issue. Once received, the samples were mounted, ground and polished to reveal the cross section. Figure 1 shows a Scanning Electron Microscope (SEM) image of the sample section which shows that the deposited layer is punctuated with large pores.

One understandable explanation is that the powder being included in the deposited layer is porous. The powder particles are between 20-53 microns in diameter and measurements of the pores reveal them to be 30-50 microns across, so are highly unlikely to be contained stably within a powder particle.

Since powder porosity would also not explain poor surface finish, the machine processing conditions were carefully investigated. A large retained sample of a previous batch of powder which was known to process satisfactorily was used in order to ensure a like for like comparison. After replacing a key component of the deposition system across all machines, that build quality was restored to output products that passed the stringent quality controls. It was confirmed that component deterioration across the machines was the root cause.

Figure 1 – SEM micrograph of deposited layer-substrate interface
