Using LPW's lab to rapidly complete a Root Cause Analysis of Powder Contamination.

LPW was approached by a customer operating an SLM Solutions machine to manufacture a component for an Industrial Gas Turbine application. Cracking was observed in the built component.

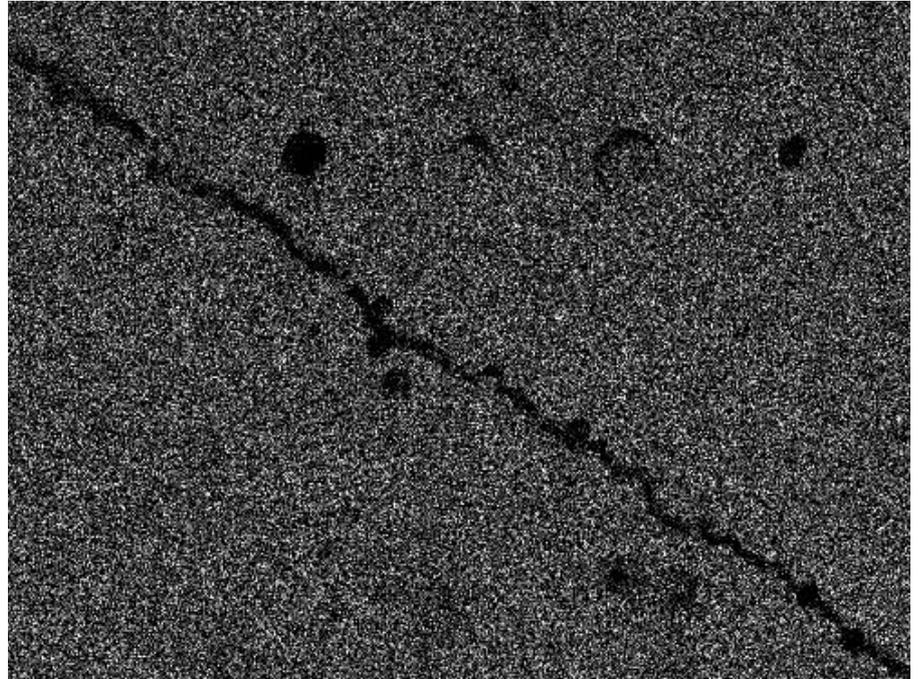
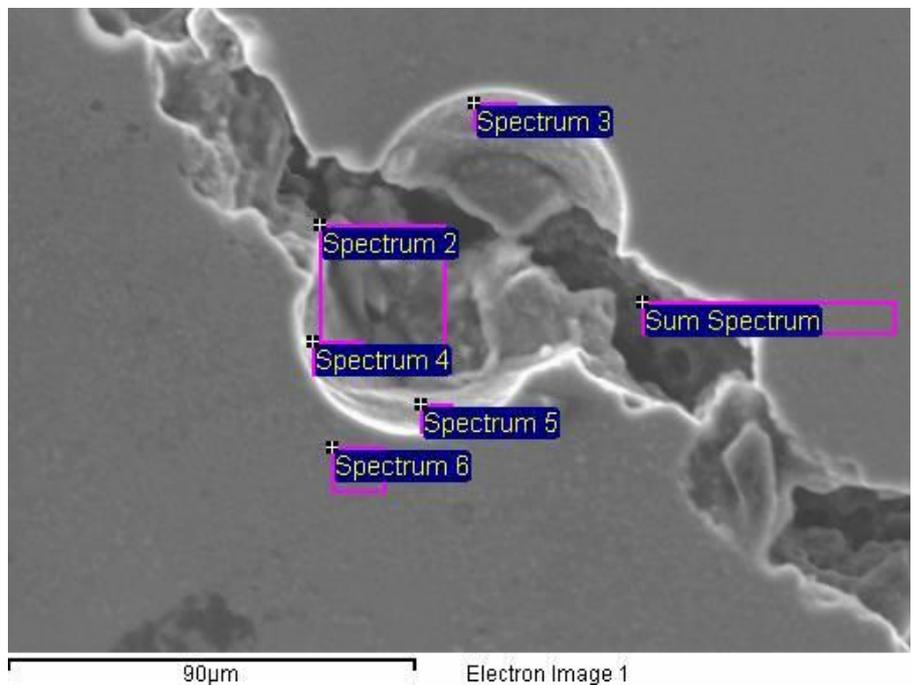
To fully understand the reasons why a small amount of Nickel alloy contamination could cause such devastating effects on the part quality, LPW’s metallurgists researched the issue.

They found that Nickel has a very limited solubility in Aluminium which means that the brittle AlNi phases appeared in the microstructure, resulting in crack propagation sites.

Further analysis of the parts which failed revealed that the Nickel was fairly homogeneously spread throughout the Aluminium matrix of the component. An average of 5.2 wt% could be observed.

This information was fed back to our customer in America who was very happy to fully understand the issue and has subsequently improved their training techniques and internal procedures.
